moore park rotunda

fact sheet

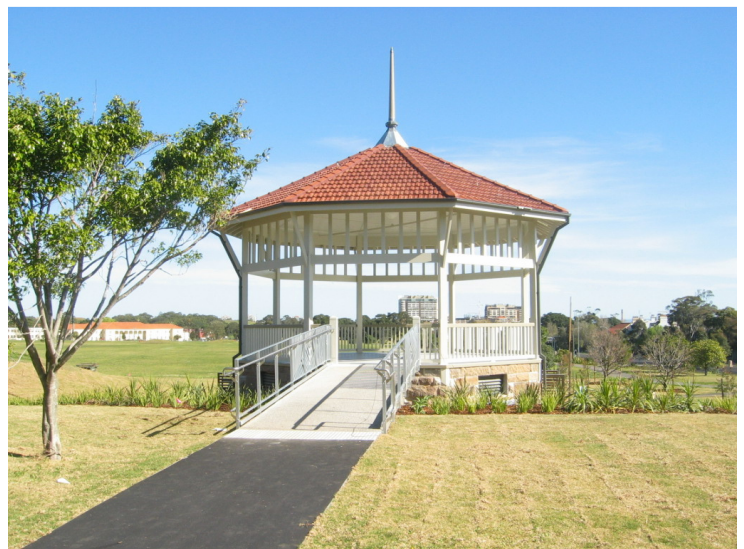
The newly refurbished rotunda at Moore Park

By 1929 the building had fallen into a state of disrepair. It was enclosed and expanded in 1936 to serve functions related to the adjacent sports field added to Moore Park West. During this development, much of the original building design was removed or obscured. The aim of the reconstruction has been to return the rotunda to its original open air bandstand form and keep as much of its original character as possible.

Elements of the building that contribute to its historical significance, such as the original sandstone base, lined timber ceiling, and its general form, have been retained.

A significant part of the project involved removing the enclosing brick walls of the upper levels of the rotunda and reconstructing the original heritage bandstand as an area for use by visitors to the Parklands. This space has not been open to the public for some time. The toilet facilities which were attached to the

Rotunda have been removed as they were a later addition to the building and were in poor condition. The sandstone from these walls has been restored and reused elsewhere in the project.

The lower level has been developed for potential future use as a café, bike hire or similar facility. The space also has an accessible toilet. The surrounding landscape has been upgraded, including a forecourt area and garden surrounds.
